# **Fluvial Geomorphology Assessment of Northern Connecticut River Tributaries**

## **Final Report**

Connecticut River Joint Commissions  
Charlestown, New Hampshire

Field Geology Services  
Farmington, ME

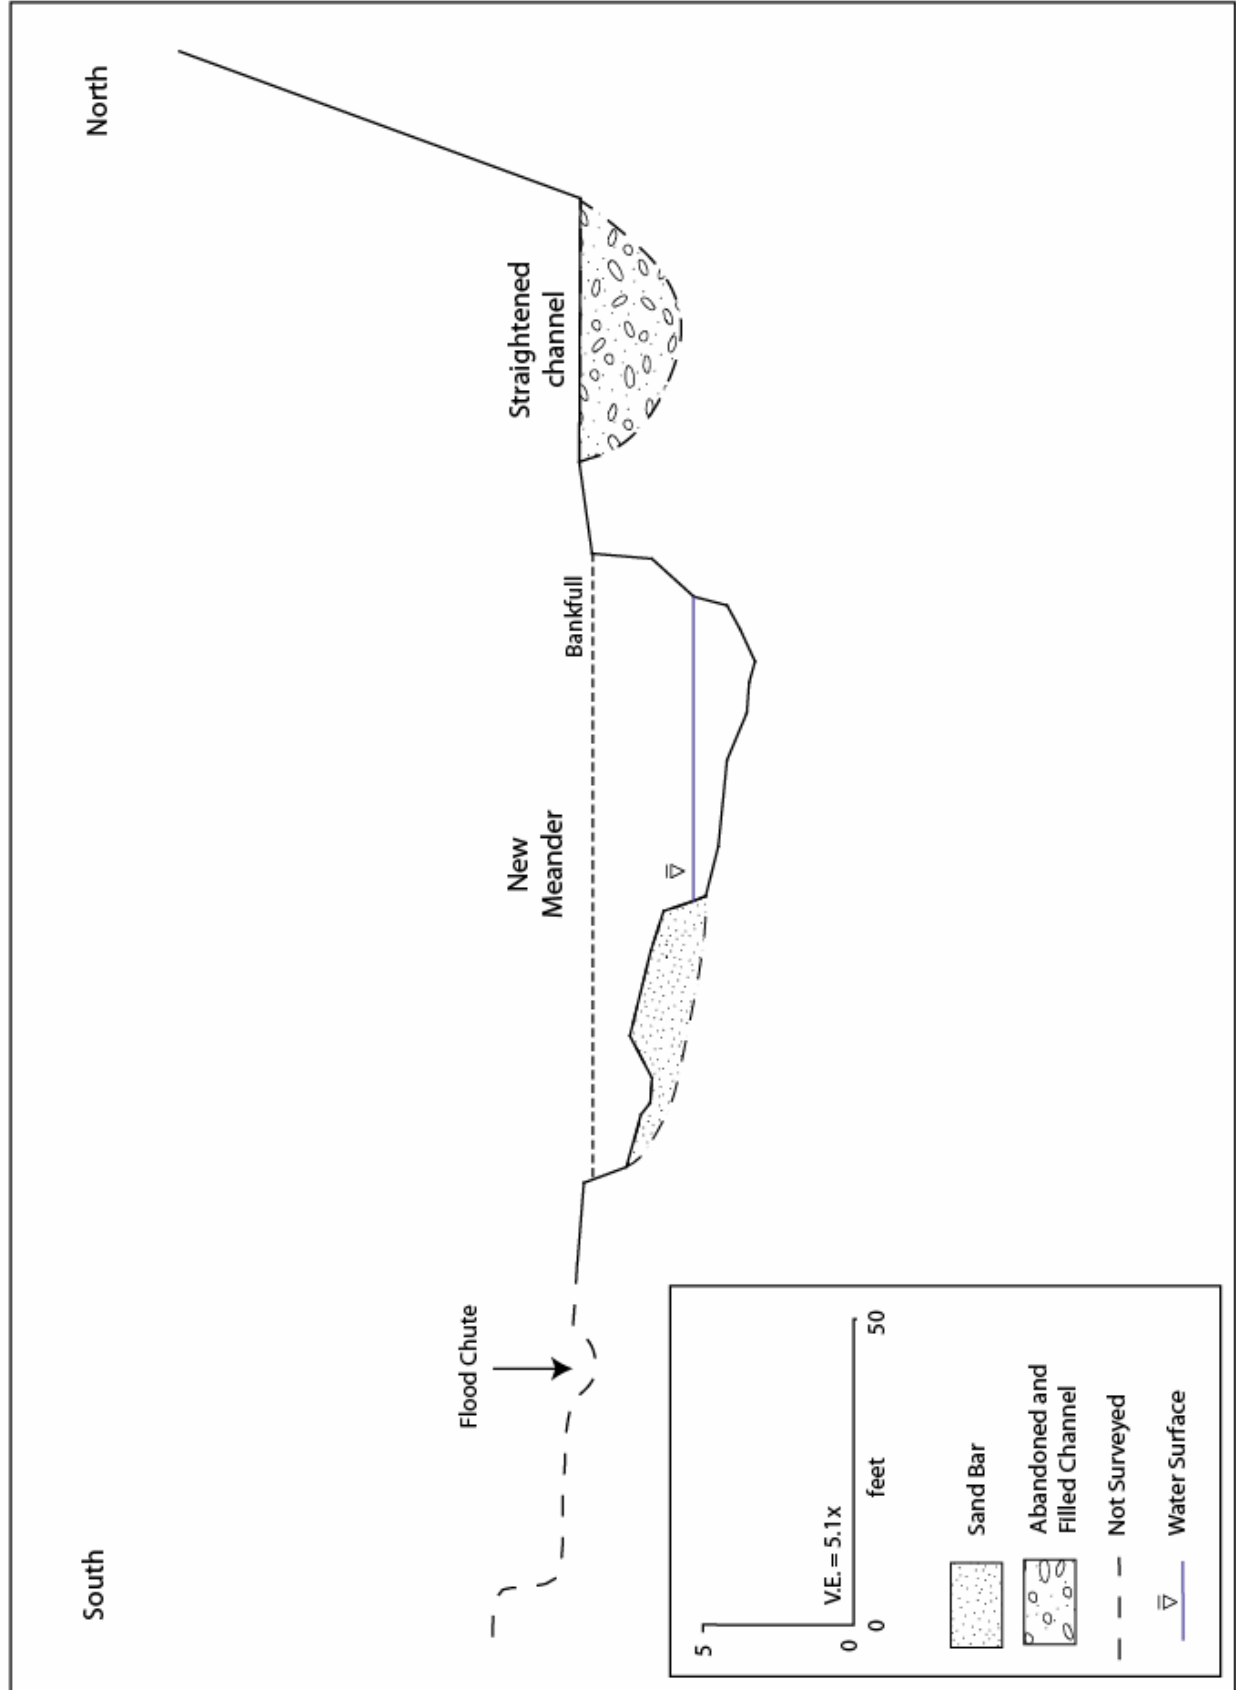
## Cross Section of "Break Out" Area (Reach T4.05)

Figure 20: Cross section of “break out” area on the Mohawk River

The morphology of the newly created meanders is characterized by large gravel bars, flood chutes, and an emerging pool riffle bed form (Figure 20). Adjacent straightened channels have a plane bed morphology with little bar formation. As flow escapes onto the floodplain, the sediment carrying capacity of the stream is lost and the sediment forms bars. The flow, now devoid of sediment, has the capacity to scour the floodplain, forming a new channel and, in some cases, additional flood chutes that run through the floodplain vegetation.

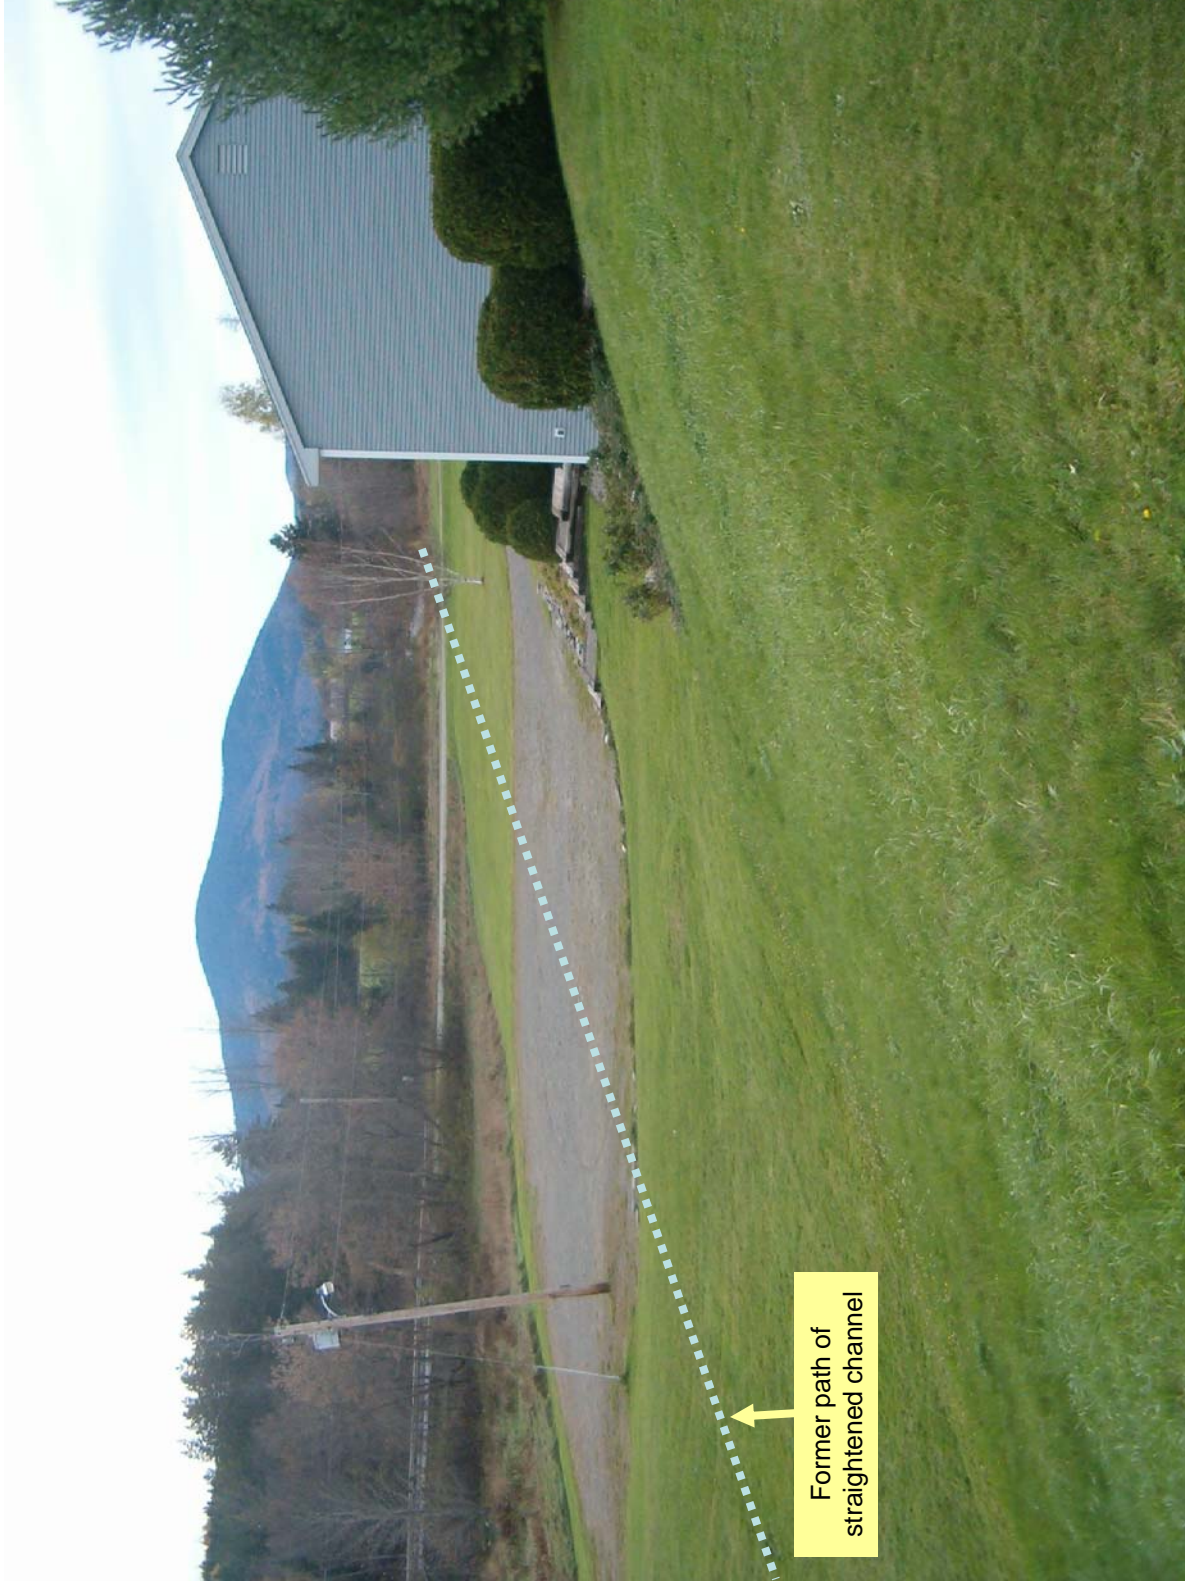
## Abandoned and Filled Straightened Channel (Reach T4.05)

Figure 21: Abandoned and filled straightened channel on the Mohawk River

Note: Photograph is taken in the middle abandoned channel of the three shown in Figure 19

While the morphology of previously straightened channels on the Mohawk River remains relatively unchanged during small to moderate floods, the catastrophic failure of the Lake Abenaki Dam in Dixville in 1929 caused the resulting floodwaters to “break out” with enough stream power to carve new meanders across the floodplain in several places (Figures 19 and 20). “Break outs” tend to occur where the channel becomes clogged with woody debris or sediment. The “break outs” represent another process by which the channel regains sinuosity and approaches an equilibrium condition; tributary inputs being the other process as discussed above. The straightened segments cut off by the meanders are now abandoned except at one location where flow returned to the existing channel and the newly created meander was abandoned. While the abandoned straightened channels can still be observed on aerial photographs (Figure 19), these segments have been filled in many places and are hard to recognize in the field (Figure 21).

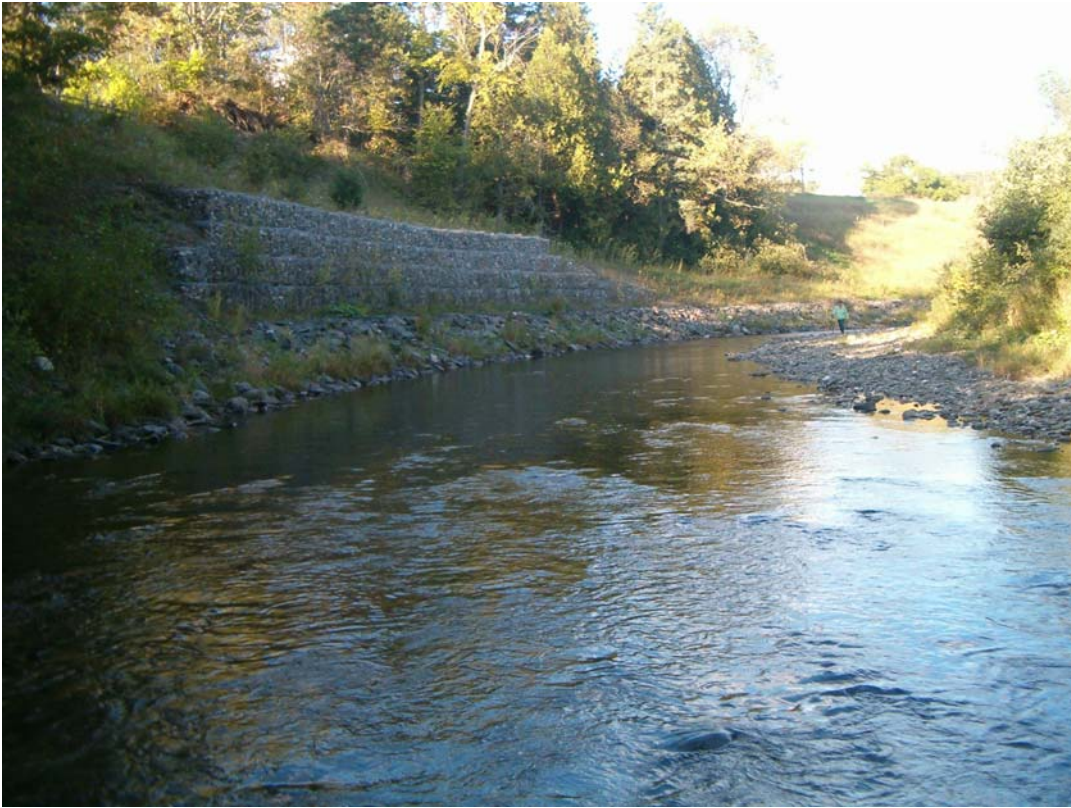
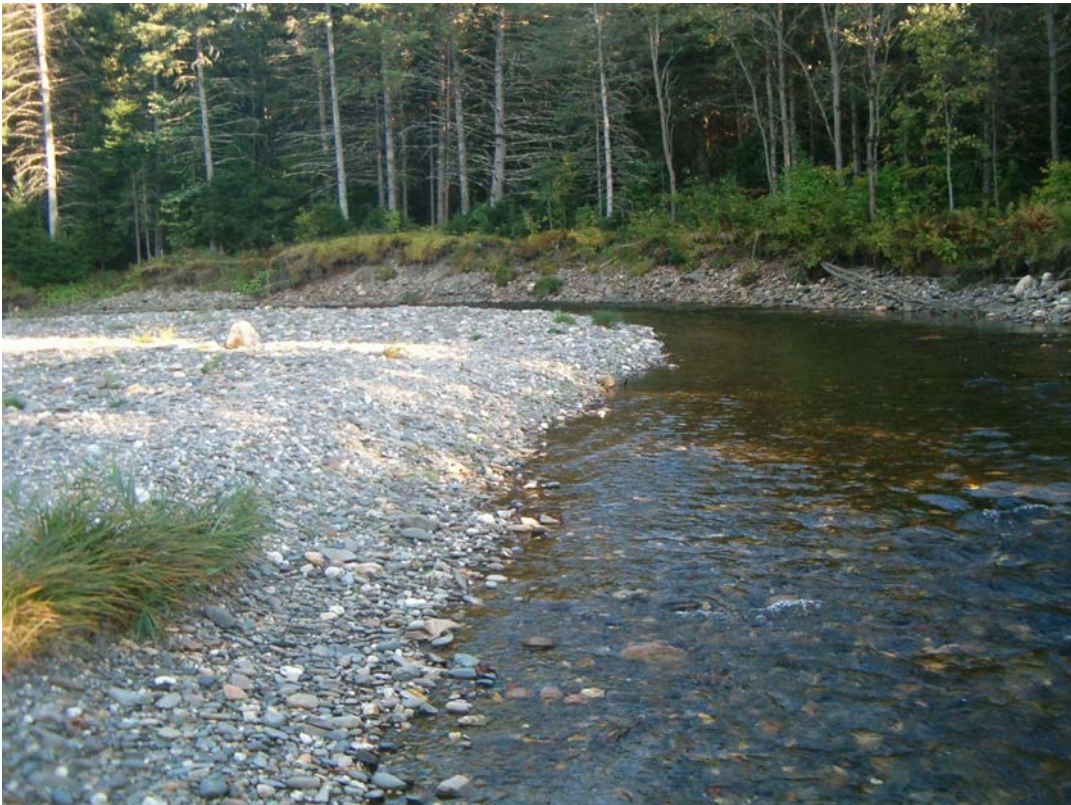
## Armored Eroding Bank Causing Downstream Deposition and Erosion (Reach T2.02)

Figure 23: a) Armored eroding bank causing b) downstream deposition and erosion

A number of other sediment sources are present in the Mohawk watershed. In addition to the ten percent of the river banks classified as eroding, another 13 percent of the banks on the Mohawk River are moderately eroding (Appendix 3). Since 80 percent of the river's banks are composed of alluvial (i.e., floodplain) soils, most of the erosion or moderate erosion occurs along low banks (Table 1 and Appendix 2). Large point sources of sediment are, thus, produced at any only a few high unstable banks (Figure 23a).

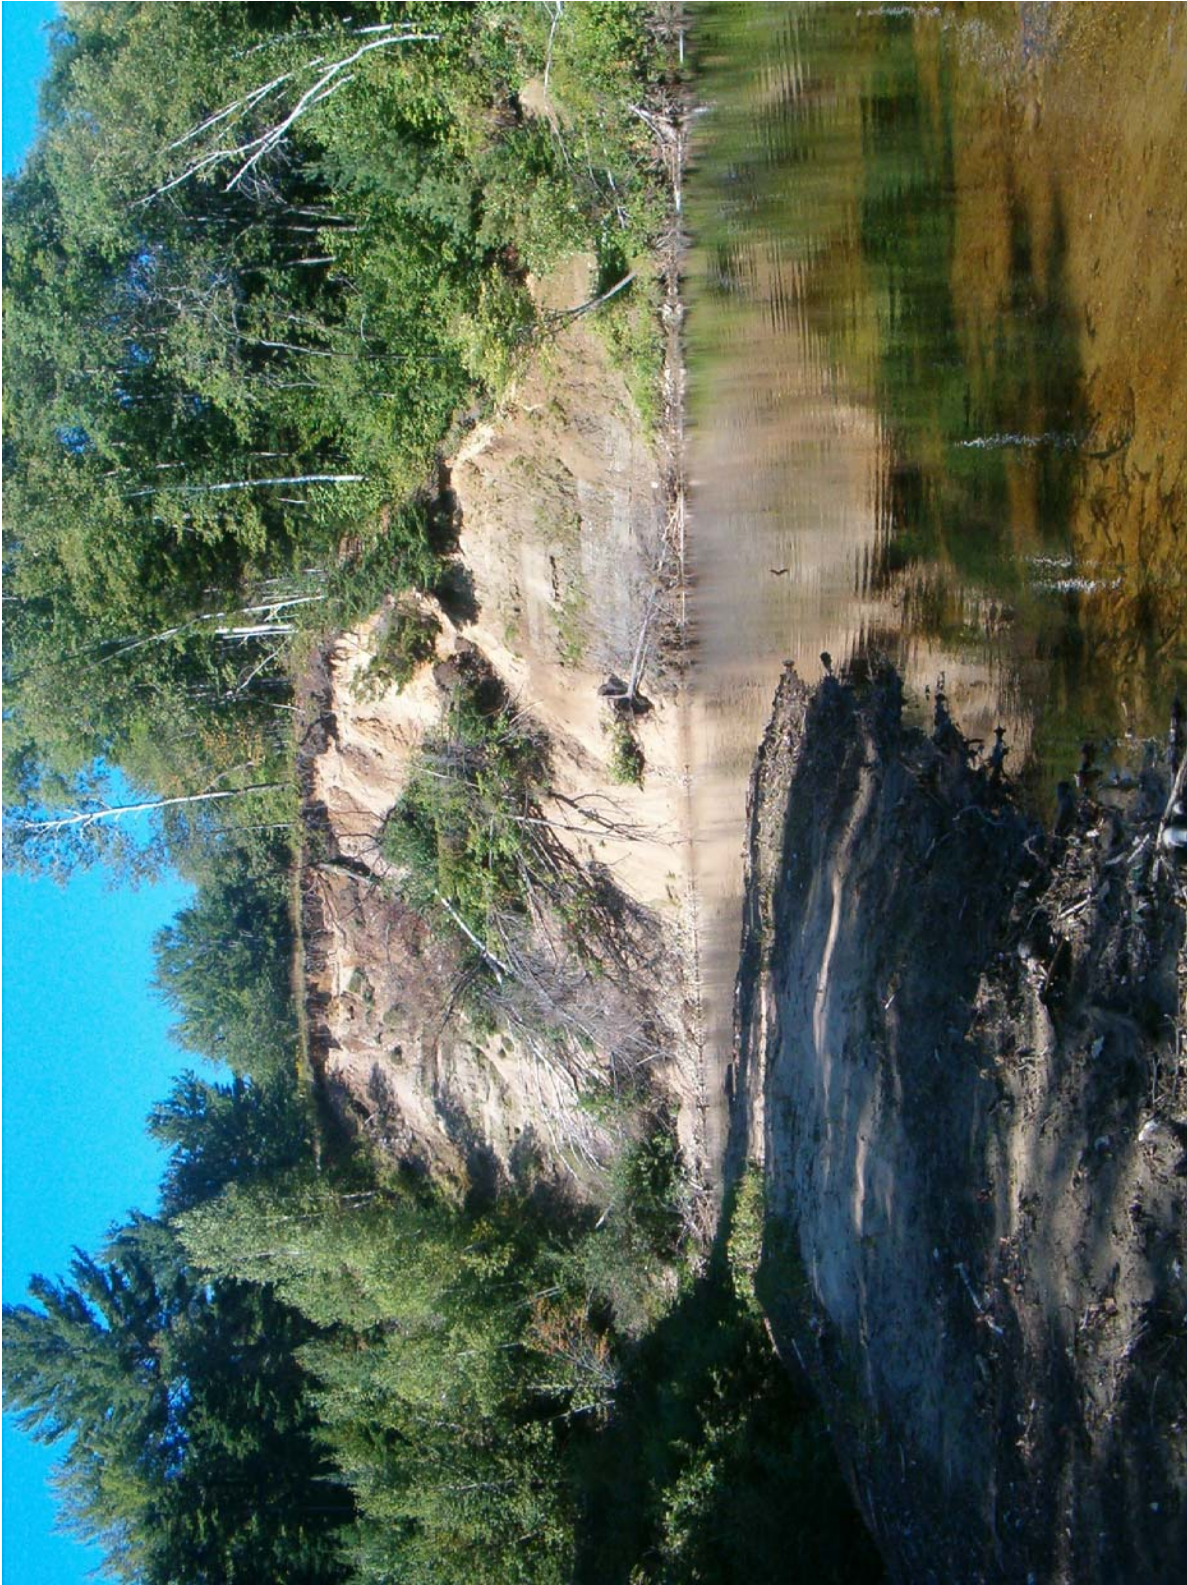
## High Eroding Bank of Glacial Outwash Deposits (Reach T2.05)

Figure 26: High eroding bank of glacial outwash deposits on the Upper Ammonoosuc River

Note: Location of photograph shown in Figure 8. View looking upstream.

Channel straightening on the Upper Ammonoosuc has focused the river's energy during high flows at "hard" bends along the channel where the end of a straightened segment rejoins the naturally meandering channel (Figure 8). Where these hard bends are coincident with high banks of glacial outwash deposits, the resulting instability generates additional sediment in the channel (Figure 26).
